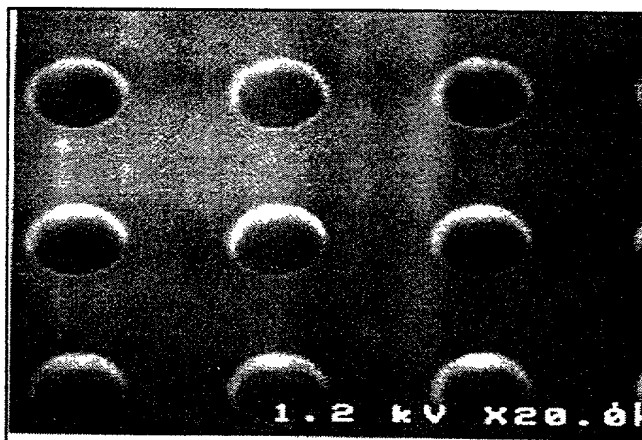
Figure 6: SEM micrograph of deep via (figure 1) after 10' exposure to moist ozone gasphase process with acetic acid spiking.

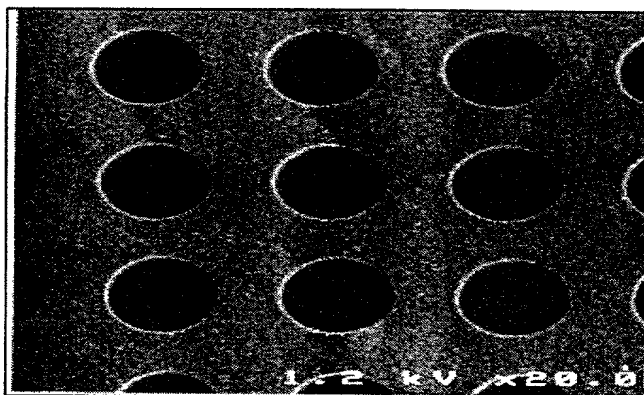
Figure 7: SEM micrograph of Al overetched via (figure 2) after 10' exposure to moist ozone gasphase process with acetic acid spiking.
